**NIST NCSTAR 1-5A** Federal Building and Fire Safety Investigation of the World Trade Center Disaster

## Visual Evidence, Damage Estimates, **And Timeline Analysis**

(Appendices D-G)

## Appendix D WTC 1 EAST FACE COMBINED FIRE AND WINDOW CONDITION AND WINDOW SMOKE CONDITION

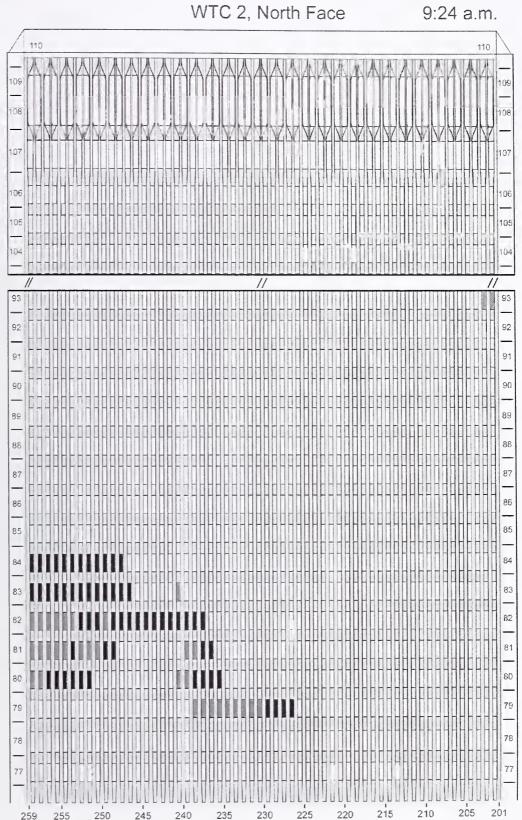
Figure G-24. Diagram of the north face of WTC 2 for floors 77 to 93 and floors 104 to 110 at 9:24 a.m. showing windows where smoke was observed and those hidden from view.

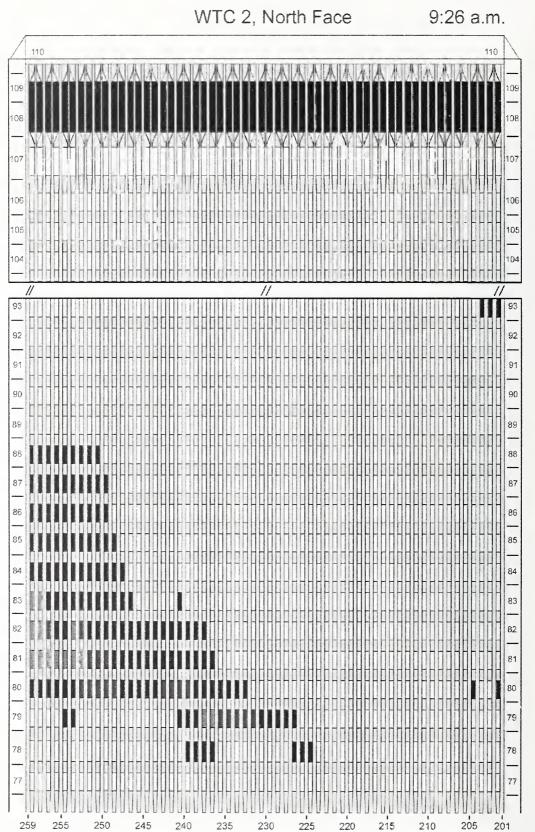
Figure G-25. Diagram of the north face of WTC 2 for floors 77 to 93 and floors 104 to 110 at 9:26 a.m. showing the condition of windows and locations of fires.

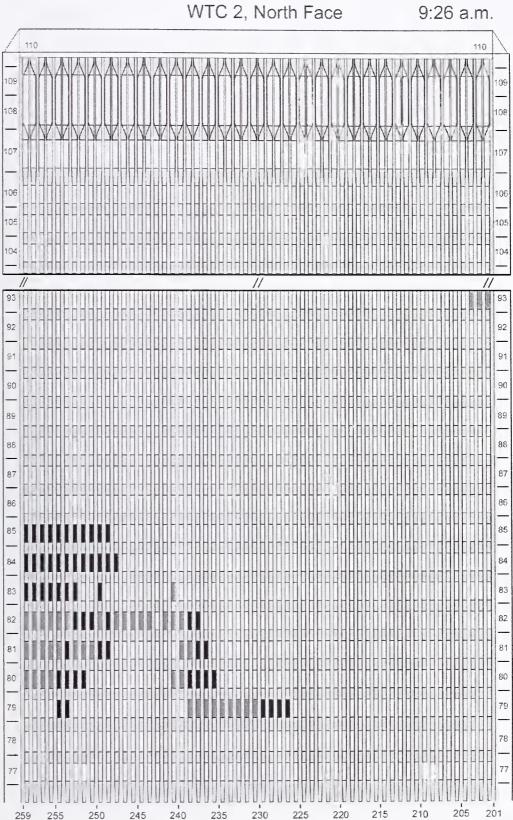
Figure G-26. Diagram of the north face of WTC 2 for floors 77 to 93 and floors 104 to 110 at 9:26 a.m. showing windows where smoke was observed and those hidden from view.

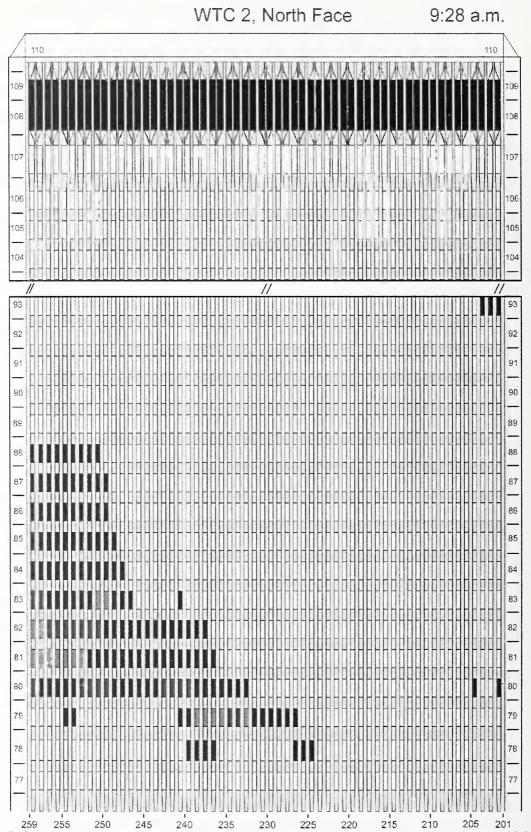
Figure G-27. Diagram of the north face of WTC 2 for floors 77 to 93 and floors 104 to 110 at 9:28 a.m. showing the condition of windows and locations of fires.

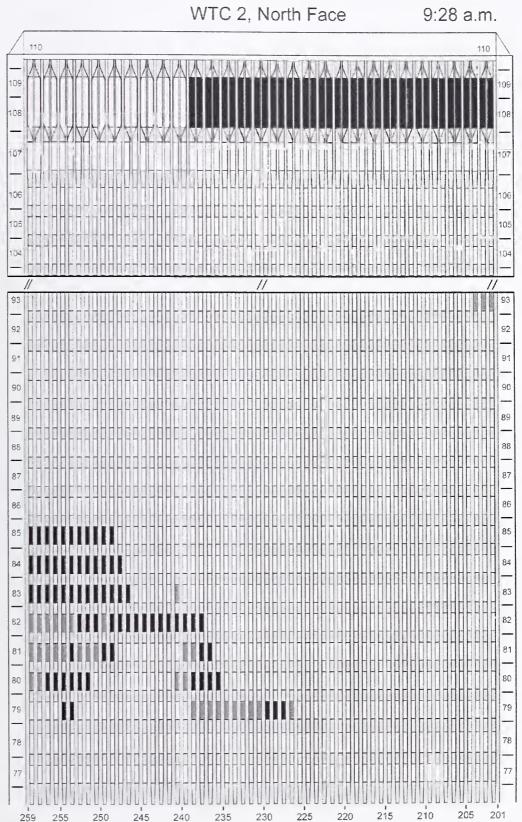
Figure G-28. Diagram of the north face of WTC 2 for floors 77 to 93 and floors 104 to 110 at 9:28 a.m. showing windows where smoke was observed and those hidden from view.

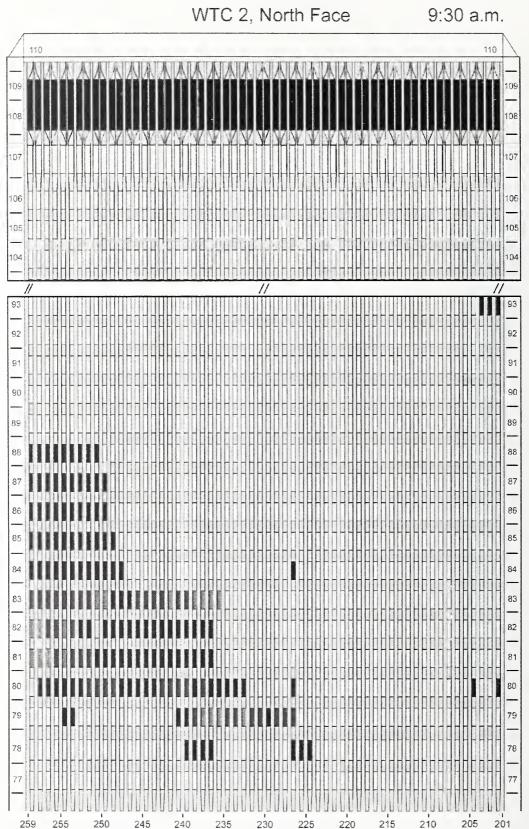
Figure G-29. Diagram of the north face of WTC 2 for floors 77 to 93 and floors 104 to 110 at 9:30 a.m. showing the condition of windows and locations of fires.

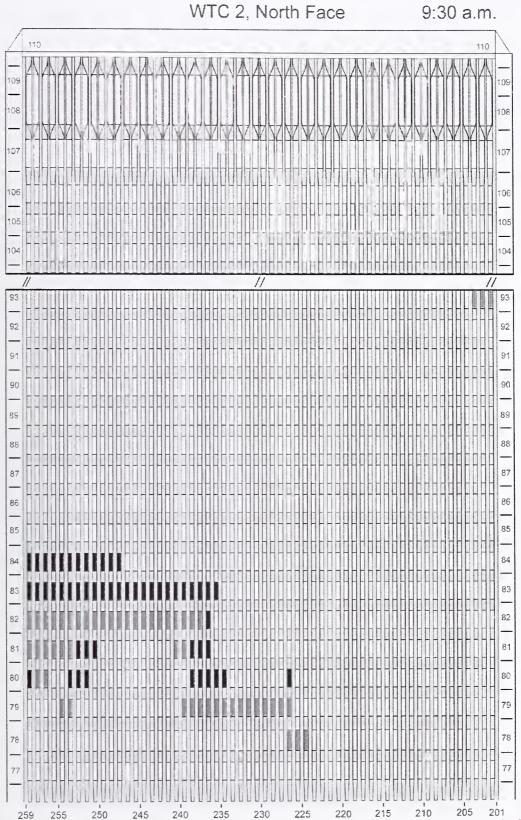
Figure G-30. Diagram of the north face of WTC 2 for floors 77 to 93 and floors 104 to 110 at 9:30 a.m. showing windows where smoke was observed and those hidden from view.

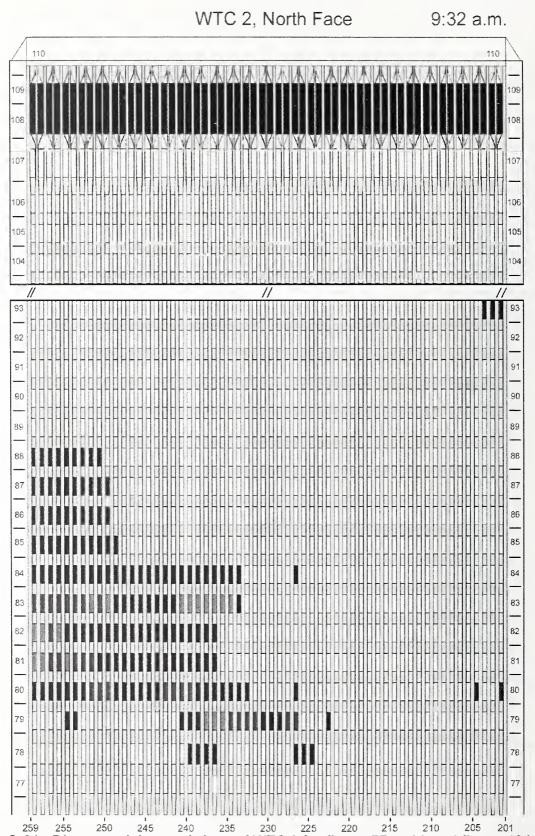
Figure G-31. Diagram of the north face of WTC 2 for floors 77 to 93 and floors 104 to 110 at 9:32 a.m. showing the condition of windows and locations of fires.

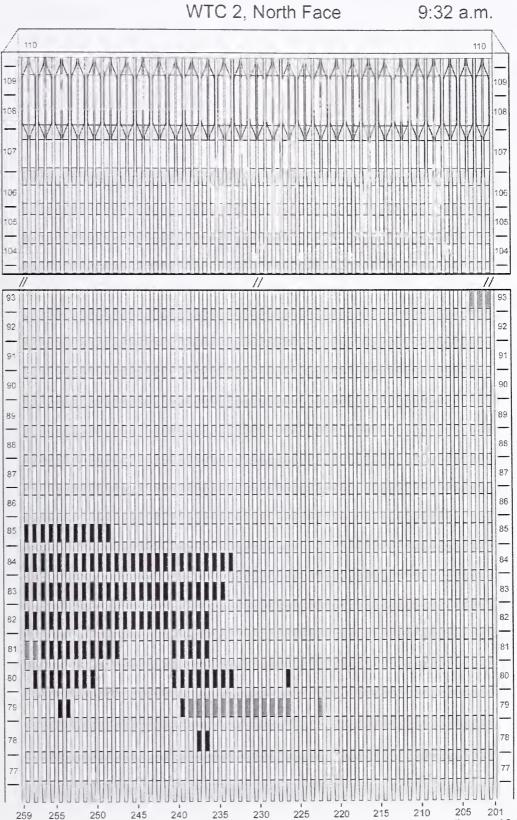
Figure G-32. Diagram of the north face of WTC 2 for floors 77 to 93 and floors 104 to 110 at 9:32 a.m. showing windows where smoke was observed and those hidden from view.

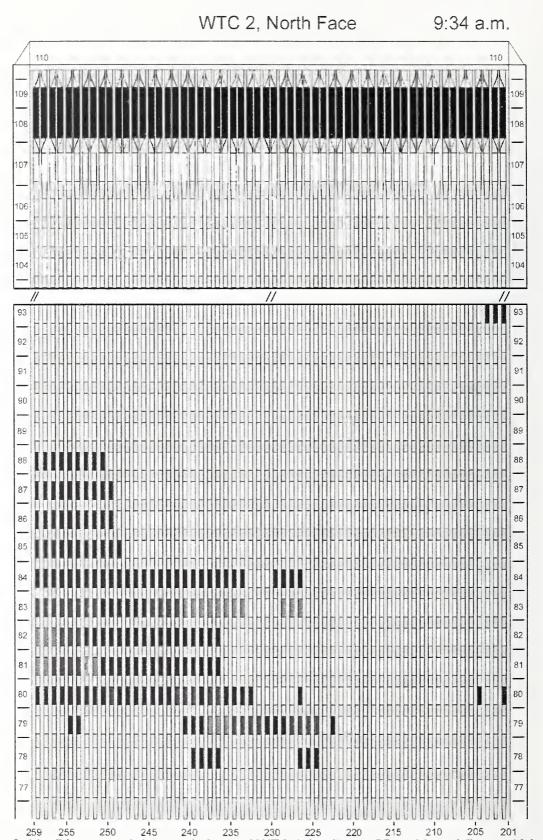
Figure G-33. Diagram of the north face of WTC 2 for floors 77 to 93 and floors 104 to 110 at 9:34 a.m. showing the condition of windows and locations of fires.

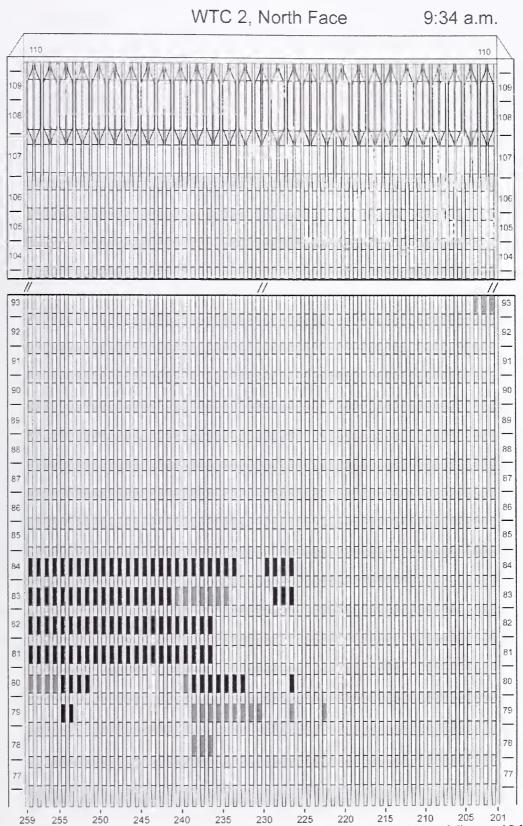
Figure G-34. Diagram of the north face of WTC 2 for floors 77 to 93 and floors 104 to 110 at 9:34 a.m. showing windows where smoke was observed and those hidden from view.

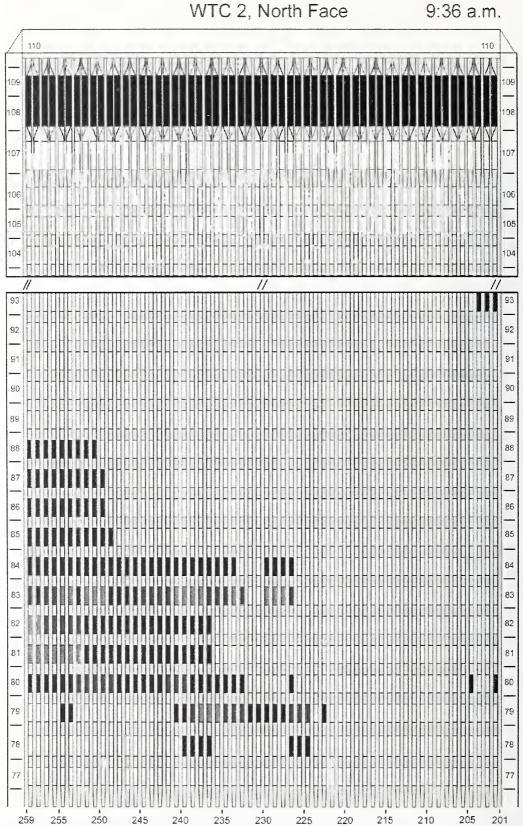
Figure G-35. Diagram of the north face of WTC 2 for floors 77 to 93 and floors 104 to 110 at 9:36 a.m. showing the condition of windows and locations of fires.

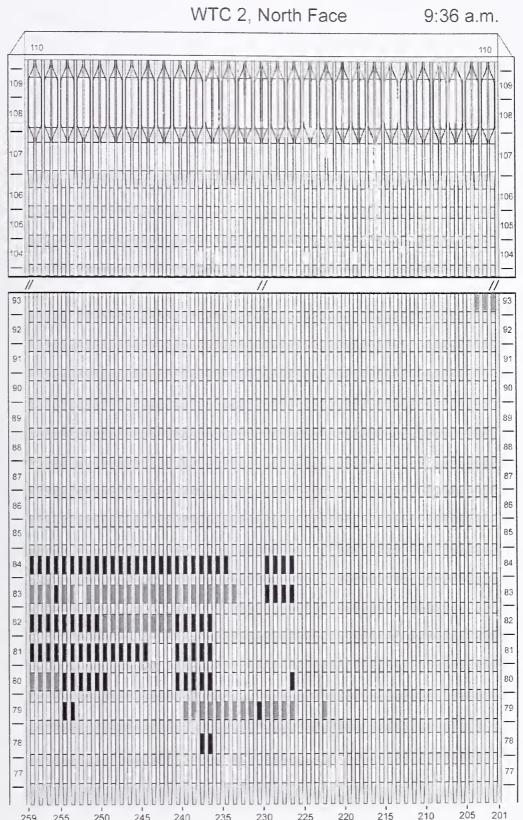
Figure G-36. Diagram of the north face of WTC 2 for floors 77 to 93 and floors 104 to 110 at 9:36 a.m. showing windows where smoke was observed and those hidden from view.

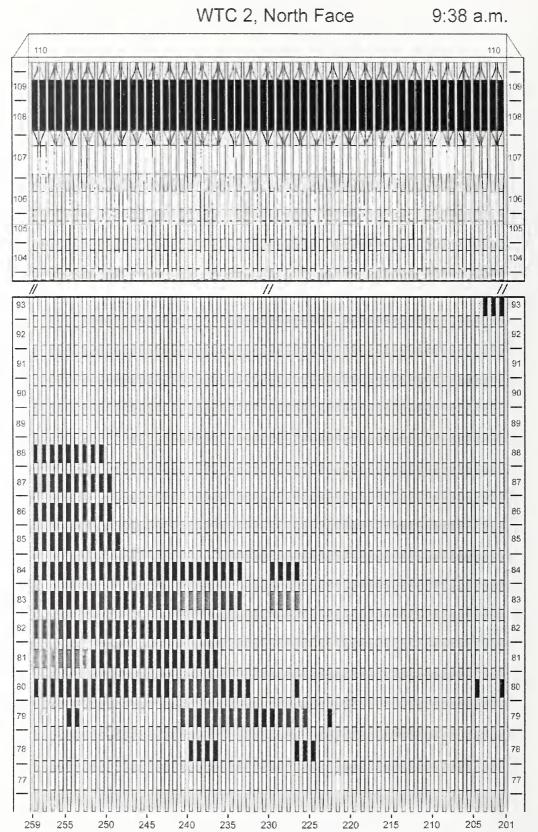
Figure G-37. Diagram of the north face of WTC 2 for floors 77 to 93 and floors 104 to 110 at 9:38 a.m. showing the condition of windows and locations of fires.

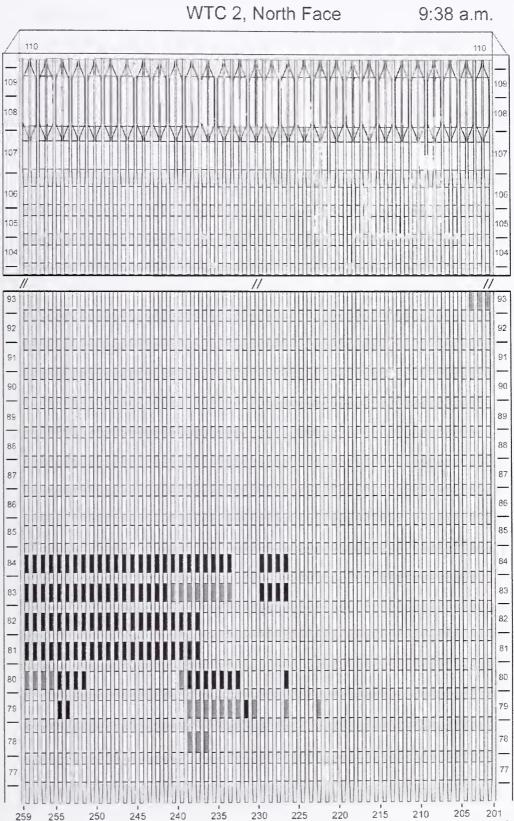
Figure G-38. Diagram of the north face of WTC 2 for floors 77 to 93 and floors 104 to 110 at 9:38 a.m. showing windows where smoke was observed and those hidden from view.

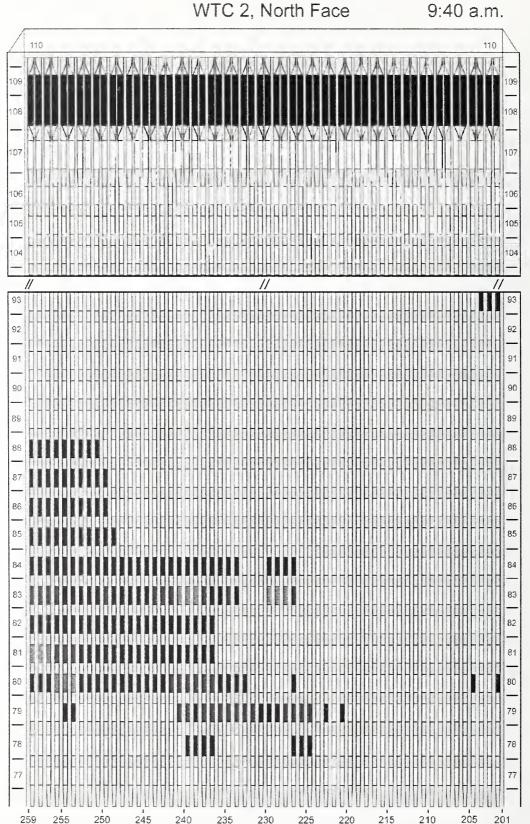
Figure G-39. Diagram of the north face of WTC 2 for floors 77 to 93 and floors 104 to 110 at 9:40 a.m. showing the condition of windows and locations of fires.

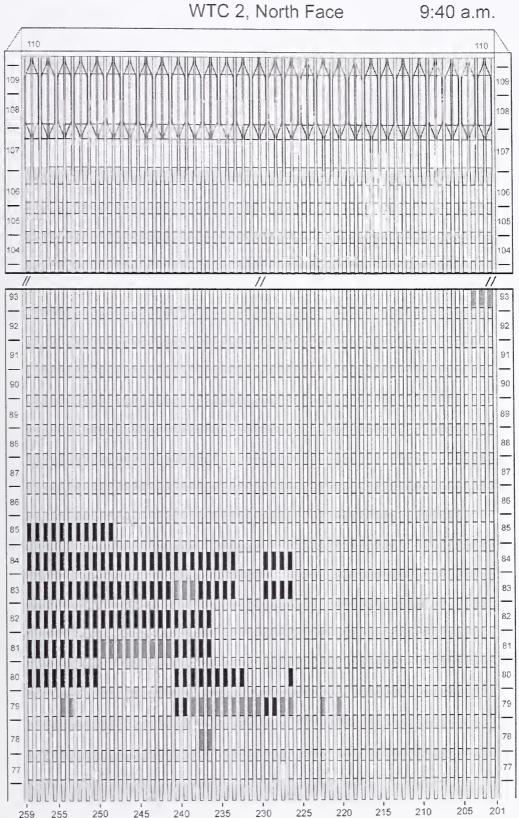
Figure G-40. Diagram of the north face of WTC 2 for floors 77 to 93 and floors 104 to 110 at 9:40 a.m. showing windows where smoke was observed and those hidden from view.

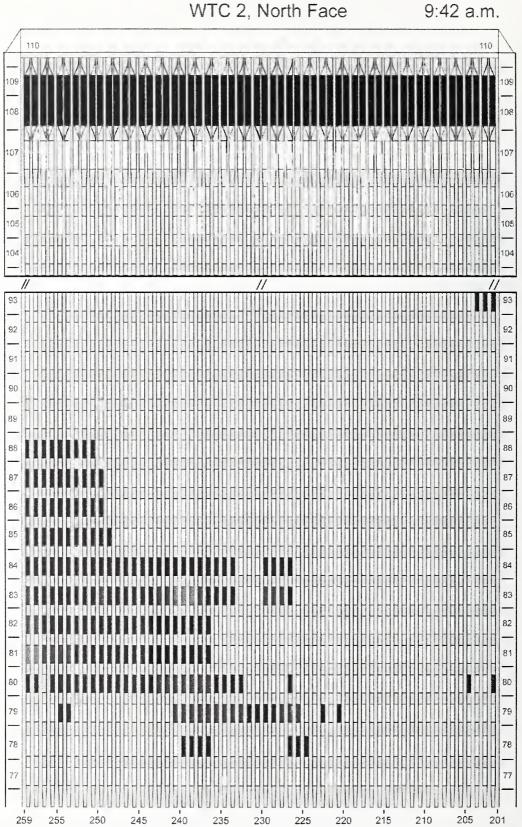
Figure G-41. Diagram of the north face of WTC 2 for floors 77 to 93 and floors 104 to 110 at 9:42 a.m. showing the condition of windows and locations of fires.

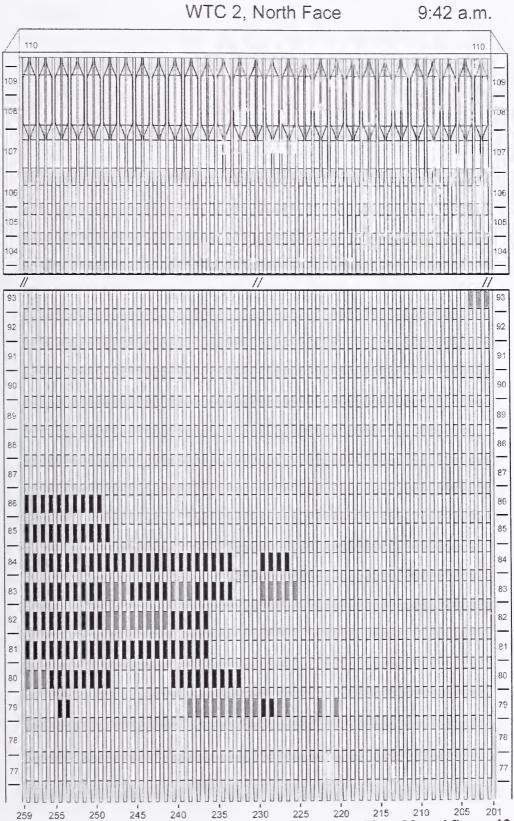
Figure G-42. Diagram of the north face of WTC 2 for floors 77 to 93 and floors 104 to 110 at 9:42 a.m. showing windows where smoke was observed and those hidden from view.

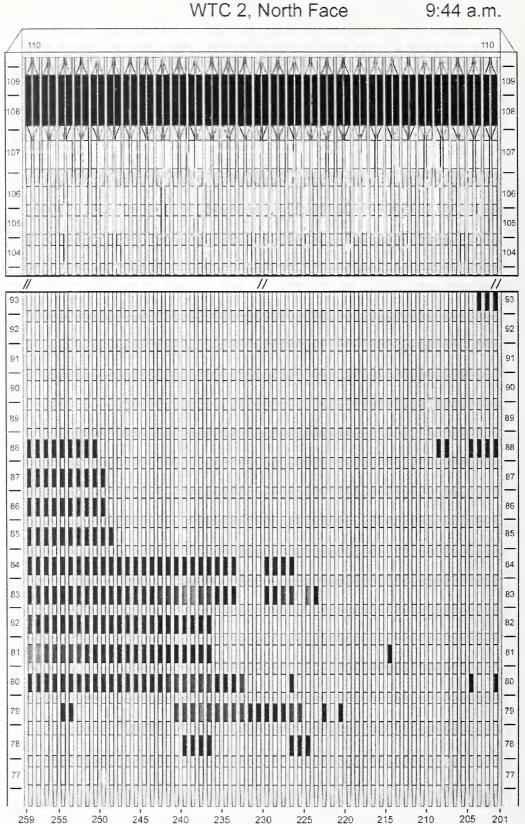
Figure G-43. Diagram of the north face of WTC 2 for floors 77 to 93 and floors 104 to 110 at 9:44 a.m. showing the condition of windows and locations of fires.

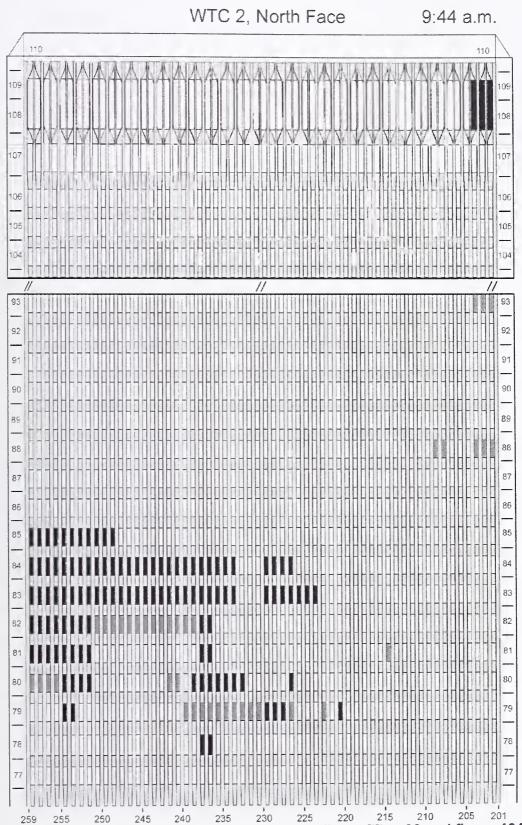
Figure G-44. Diagram of the north face of WTC 2 for floors 77 to 93 and floors 104 to 110 at 9:44 a.m. showing windows where smoke was observed and those hidden from view.

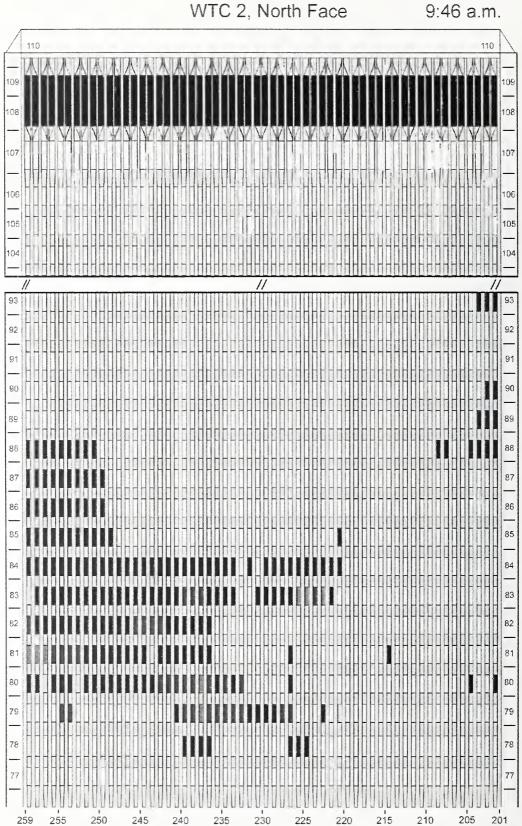
Figure G-45. Diagram of the north face of WTC 2 for floors 77 to 93 and floors 104 to 110 at 9:46 a.m. showing the condition of windows and locations of fires.

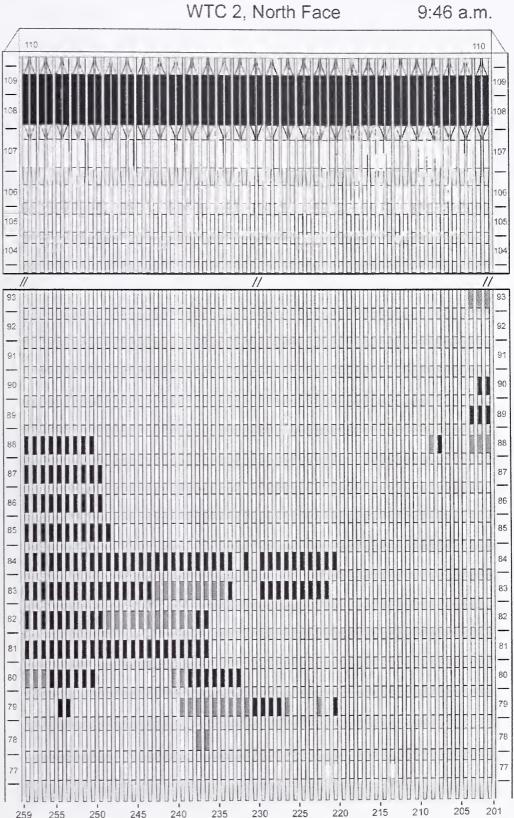
Figure G-46. Diagram of the north face of WTC 2 for floors 77 to 93 and floors 104 to 110 at 9:46 a.m. showing windows where smoke was observed and those hidden from view.

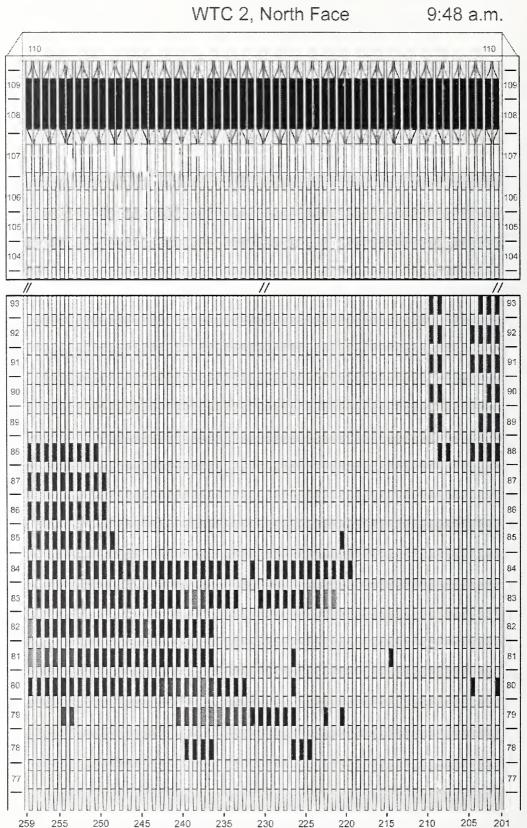
Figure G-47. Diagram of the north face of WTC 2 for floors 77 to 93 and floors 104 to 110 at 9:48 a.m. showing the condition of windows and locations of fires.

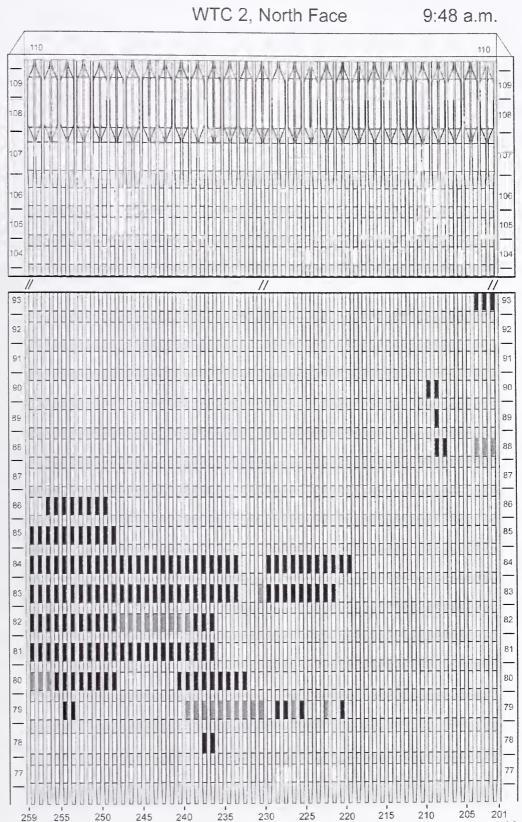
Figure G- 48. Diagram of the north face of WTC 2 for floors 77 to 93 and floors 104 to 110 at 9:48 a.m. showing windows where smoke was observed and those hidden from view.

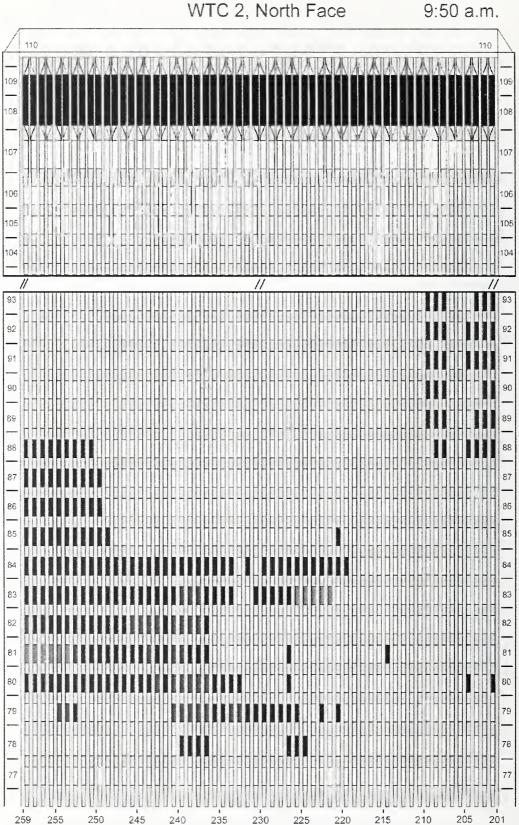
Figure G-49. Diagram of the north face of WTC 2 for floors 77 to 93 and floors 104 to 110 at 9:50 a.m. showing the condition of windows and locations of fires.

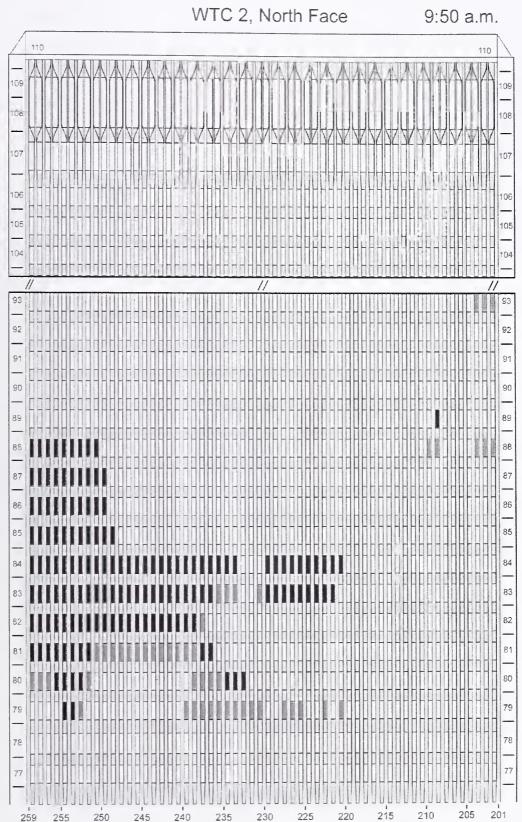
Figure G-50. Diagram of the north face of WTC 2 for floors 77 to 93 and floors 104 to 110 at 9:50 a.m. showing windows where smoke was observed and those hidden from view.

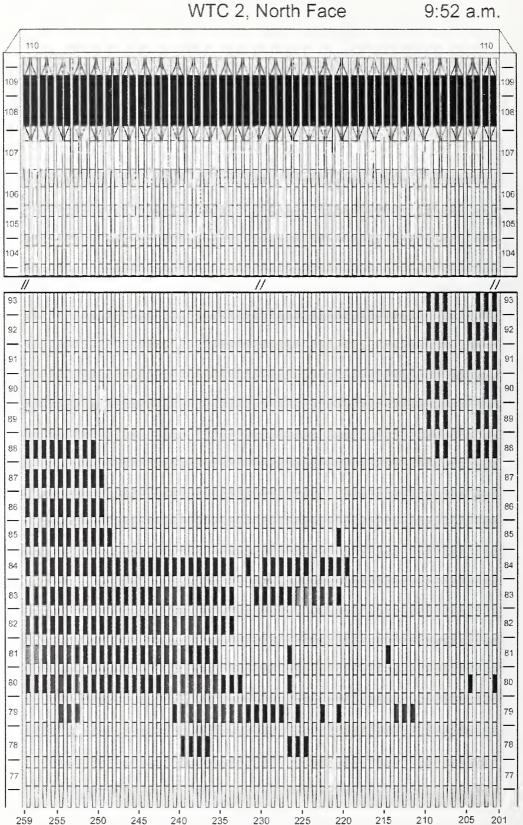
Figure G-51. Diagram of the north face of WTC 2 for floors 77 to 93 and floors 104 to 110 at 9:52 a.m. showing the condition of windows and locations of fires.

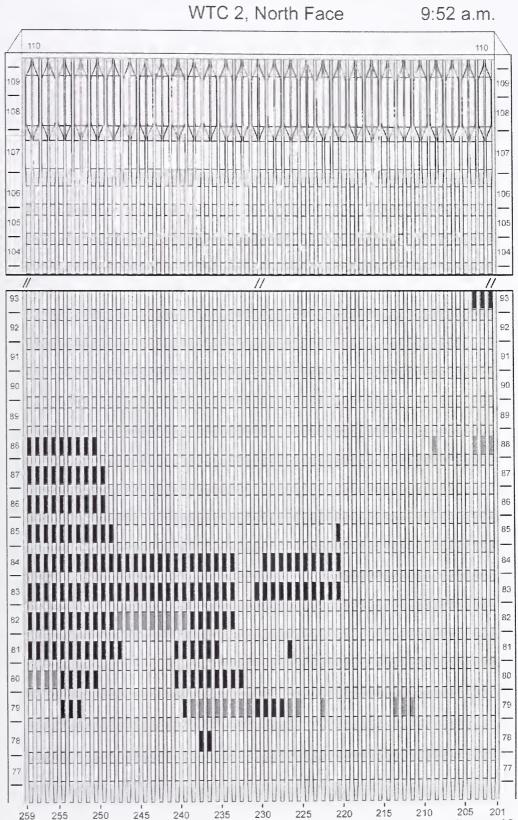
Figure G-52. Diagram of the north face of WTC 2 for floors 77 to 93 and floors 104 to 110 at 9:52 a.m. showing windows where smoke was observed and those hidden from view.

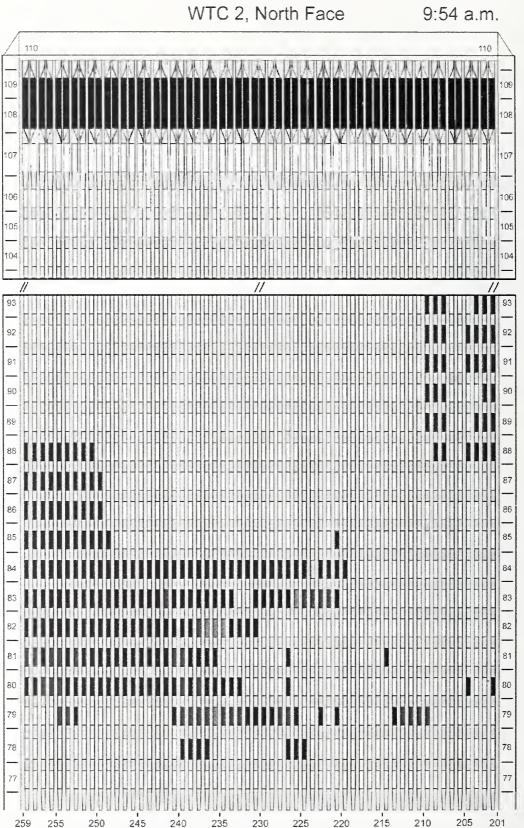
Figure G-53. Diagram of the north face of WTC 2 for floors 77 to 93 and floors 104 to 110 at 9:54 a.m. showing the condition of windows and locations of fires.

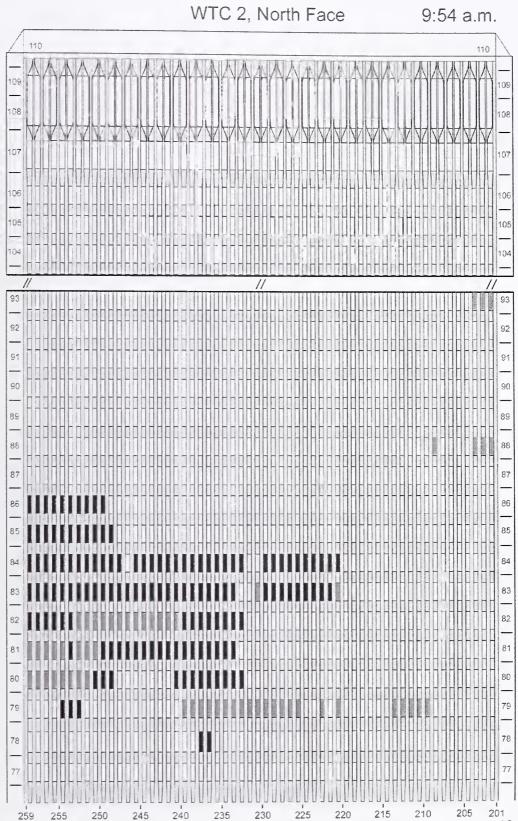
Figure G-54. Diagram of the north face of WTC 2 for floors 77 to 93 and floors 104 to 110 at 9:54 a.m. showing windows where smoke was observed and those hidden from view.

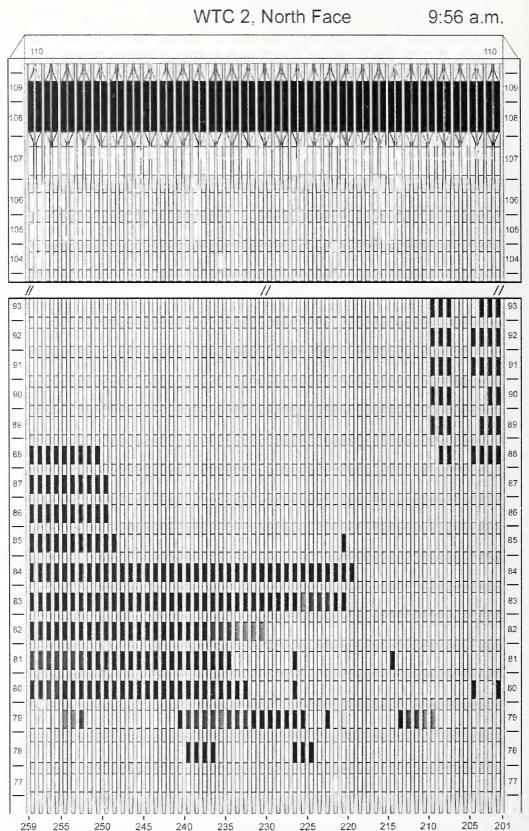
Figure G-55. Diagram of the north face of WTC 2 for floors 77 to 93 and floors 104 to 110 at 9:56 a.m. showing the condition of windows and locations of fires.

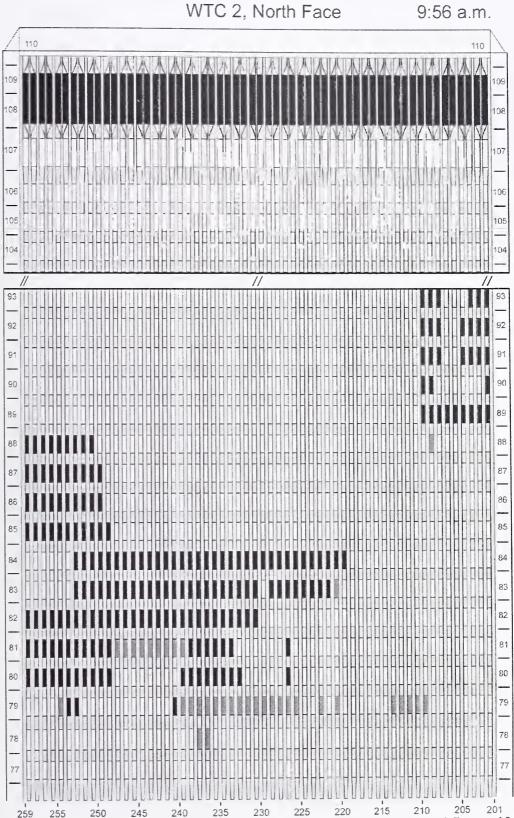
Figure G-56. Diagram of the north face of WTC 2 for floors 77 to 93 and floors 104 to 110 at 9:56 a.m. showing windows where smoke was observed and those hidden from view.

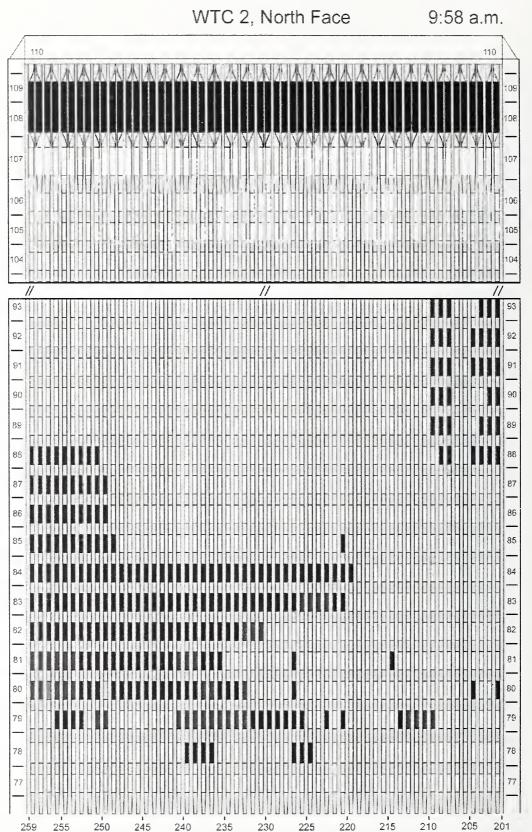
Figure G-57. Diagram of the north face of WTC 2 for floors 77 to 93 and floors 104 to 110 at 9:58 a.m. showing the condition of windows and locations of fires.

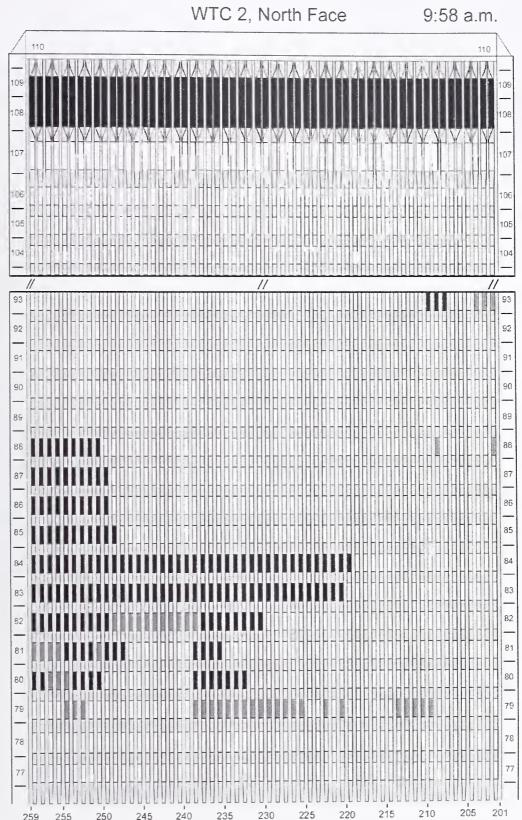
Figure G-58. Diagram of the north face of WTC 2 for floors 77 to 93 and floors 104 to 110 at 9:58 a.m. showing windows where smoke was observed and those hidden from view.
